Bethany Beyond the Jordan Site of Jesus Baptism: A Threatened Site

ABSTRACT The discovery of the Baptism Site is considered as a major step in field of archaeology and cultural heritage in Jordan Valley on the eastern bank of Jordan River. The ecology of the site played a vital role in the events occurred during the early history of the site during Roman and Byzantine period. The article has discussed the major threats to the ecology, heritage and eco-tourism at the component of the site, and the possible mitigations measures in order to sustain the site for future generations. The proposed procedures to protect the identified sites includes enhancement the restoration and preservation of the components in order to reduce the negative impacts and strengthen coordination between the Conservation section of the baptism site by creating an architectural conservation staff formed exclusively by professionals according to the Venice Charter regulations. A well established conservation process is needed to minimize these effects, and to protect the archeological and heritage sites in Bethany beyond the Jordan.

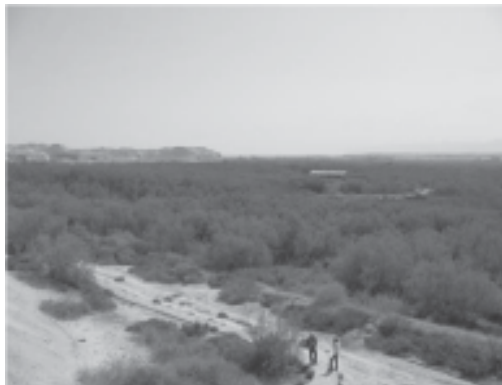
Fig. 5. The ecology of Bethany Beyond the Jordan and John the Baptist church.

wall surface. As the inside raising water depends on the thickness of the wall, the height of rise is greater for thicker walls. The influence of gravity, opposing the rise, appears to be negligible with respect to the effect of evaporation. Air circulation near the surface accelerates evaporation and causes a reduction of the moisture level.

In the long run, soluble salts also play a role in the evaporation surfaces. Besides causing damage when they crystallize, salts attract water by osmosis and can determine a further rise of the water level. As accumulation of salt never stops, it is likely that a stable equilibrium is never reached. The best example for this case is John the Baptist church near Jordan River (Figs.5 and 6).
