Bethany Beyond the Jordan Site of Jesus Baptism: A Threatened Site

ABSTRACT The discovery of the Baptism Site is considered as a major step in field of archaeology and cultural heritage in Jordan Valley on the eastern bank of Jordan River. The ecology of the site played a vital role in the events occurred during the early history of the site during Roman and Byzantine period. The article has discussed the major threats to the ecology, heritage and eco-tourism at the component of the site, and the possible mitigations measures in order to sustain the site for future generations. The proposed procedures to protect the identified sites includes enhancement the restoration and preservation of the components in order to reduce the negative impacts and strengthen coordination between the Conservation section of the baptism site by creating an architectural conservation staff formed exclusively by professionals according to the Venice Charter regulations. A well established conservation process is needed to minimize these effects, and to protect the archeological and heritage sites in Bethany beyond the Jordan.

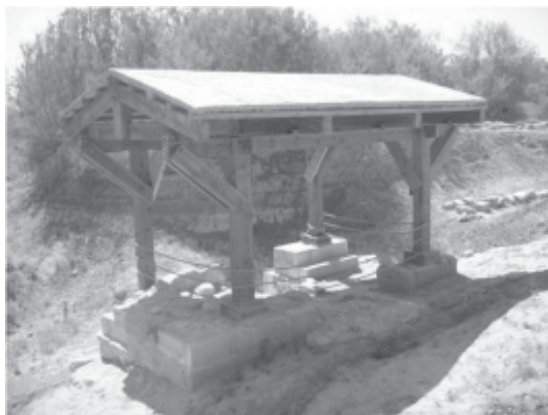
The feeding waters of the Wadi el-Kharrar has been declining in the past few years, due to agricultural acts as a new source of water, to keep the circulating water in the wetland, maintain its natural features and preserve the ecological features of the site against any possible drying in the future (Figs. 3 and 4).

Fig. 3. The small church close to the Jordan River

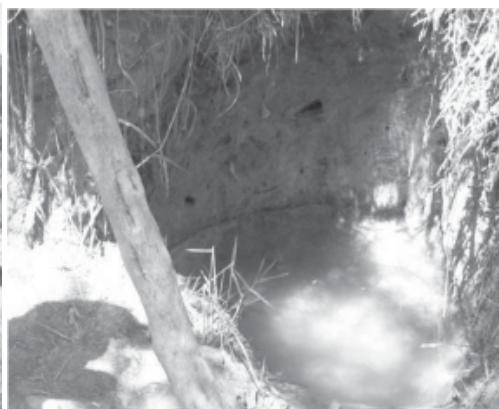
The conversion of the feature of water running under some sites near Wadi el-Kharrar from being pure natural to polluted water mixed with the waste outcome of factories, black water full of chemical agents and organic salts all cause a very critical and serious problem to the foundations and lower parts of stone walls.

Fig. 4. Spring of John the Baptist in the heat of Bethany Beyond the Jordan

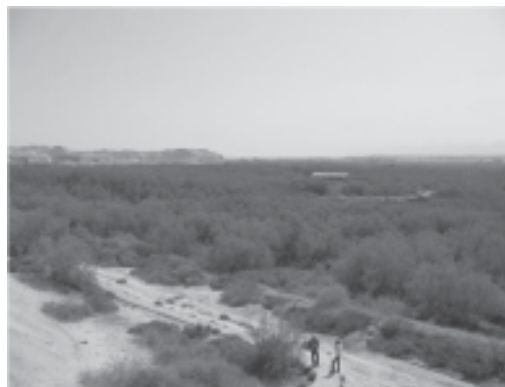
In the long run, soluble salts also play a role in the evaporation surfaces. Besides causing damage when they crystallize, salts attract water by osmosis and can determine a further rise of the water level. As accumulation of salt never stops, it is likely that a stable equilibrium is never reached. The best example for this case is John the Baptist church near Jordan River (Figs. 5 and 6).

Fig. 5. The ecology of Bethany Beyond the Jordan and John the Baptist church.

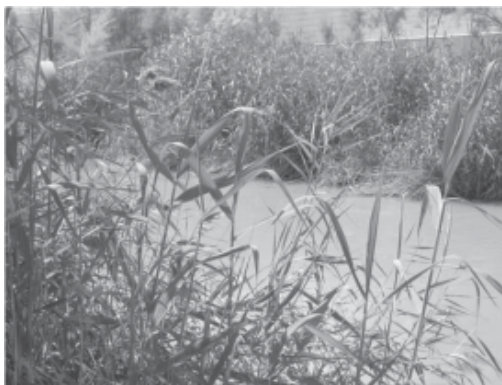
Fig. 6. The traditional spot of Baptism (Jordan river)

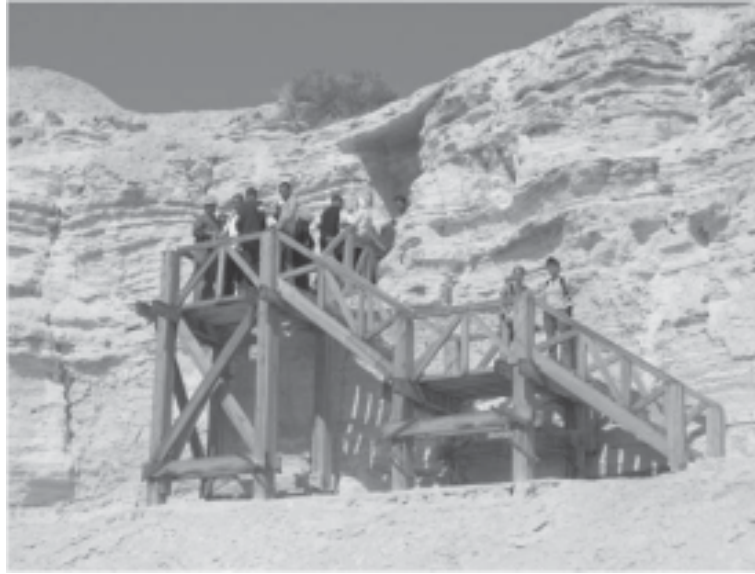
The working stone techniques, thermal expansion, wind erosion and the traffic vibration. Mechanical stresses induced in a building material by its environment can lead to damage, particularly in the case of tensile stresses towards which the resistance of brittle materials is low. Even if actual macroscopic breaking does not occur, stress can be the cause of permanent deformation and microscopic cracks, resulting

in an overall acceleration of the weathering rate. There are several mechanisms that can generate localized high stresses in building materials (Fig.7) (Lazzarini and Tabasso 1998).

Fig. 7. The caves of the monks dug in the natural lissan marl
